## 8.0 Great Pond Bay Watershed

### 8.3 Potential Watershed Restoration/Project Sites

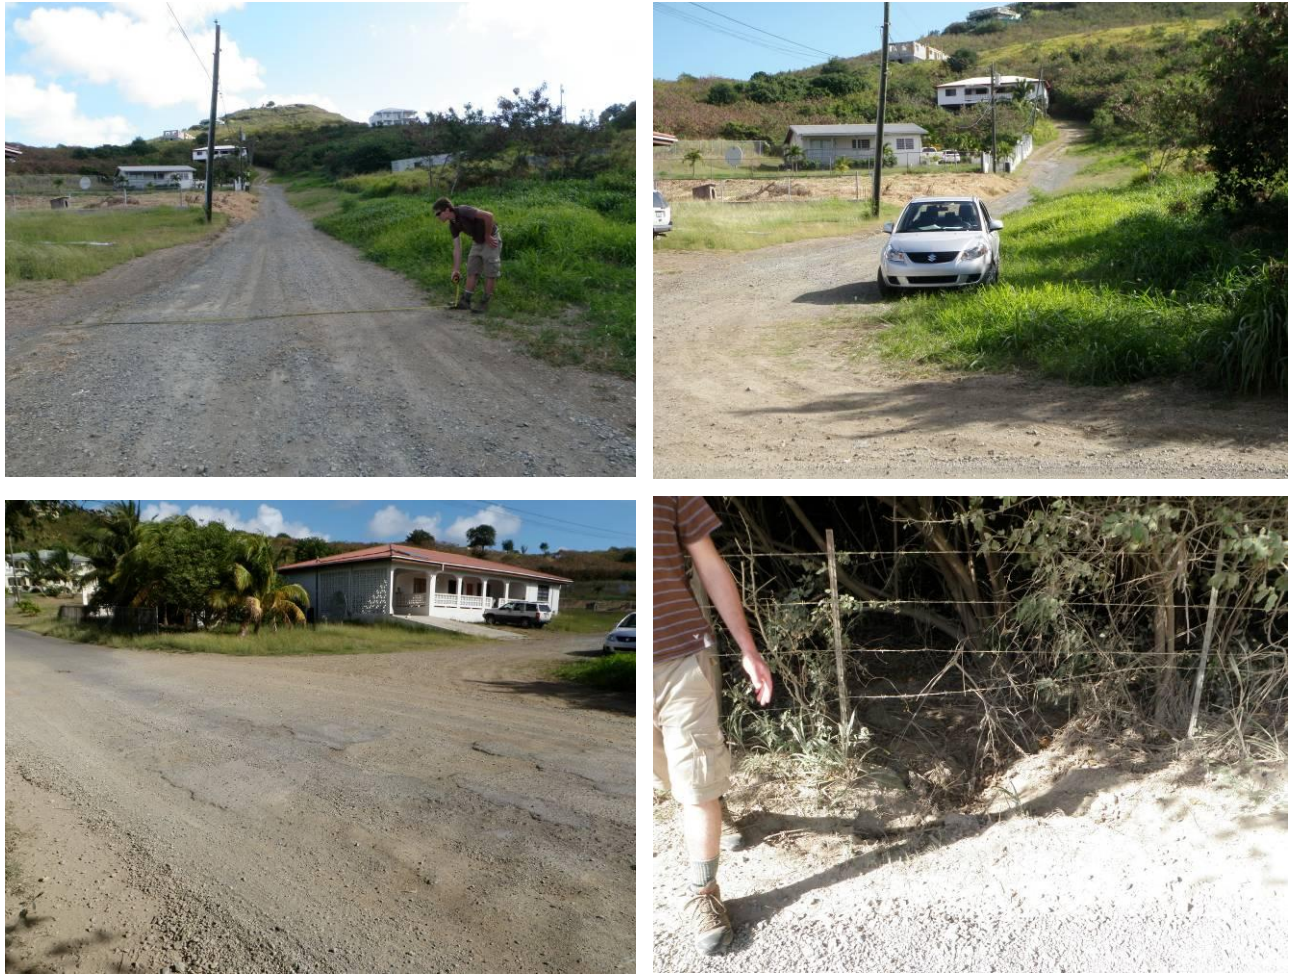
Just off of South Shore Rd., north of the Union neighborhood area, is a private unpaved road that is contributing sediment across South Shore Rd. and contributing to pavement degradation (Figure 8.2). The road is approximately 600 ft. long, currently serving four to five houses. A number of strategically placed water bars could help prevent erosion of the road surface by breaking up the flow and conveying it to a stabilized concrete swale. There is room to collect flow at the base of the slope in a drop inlet structure and pipe it under South Shore Rd. to a stabilized outfall. The inlet sump could help trap sediment, but would require maintenance.

**Figure 8.2.** Unnamed, unpaved road (top photos) draining to South Shore Rd. deposits sediment across South Shore Rd. into vegetated area and is contributing to road surface degradation (bottom photos).

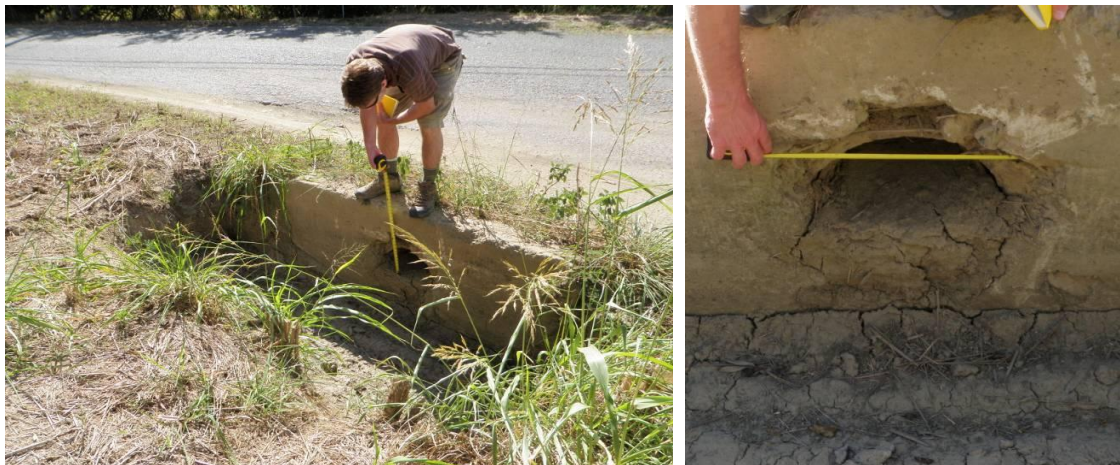
At the bend on South Shore Rd., on the northern watershed boundary, there is an existing 12" RCP that was recently excavated, presumably because lack of maintenance or undersizing of the culvert has led to the culvert being completely buried (Figure 8.3). Sediment was removed from behind the culvert headwall, however no formal box structure or roadside drainage ditch exists. This area will likely continue to be a maintenance issue. The installation of a concrete box structure with stabilized ditch inlets and outlet structure (riprap) may provide a sump for sediment that can be removed with a back hoe. Increased pipe capacity may also be recommended, depending on an analysis of the drainage area to this point.

**Figure 8.3.** Unnamed road draining to South Shore Rd. deposits sediment across street into vegetated area and is contributing to road surface degradation.

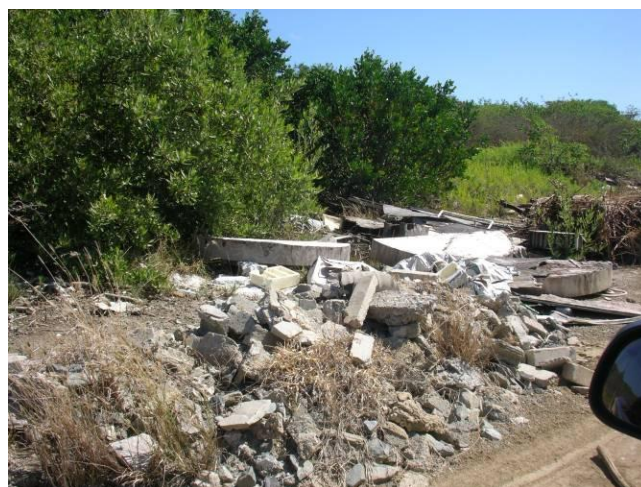
The parking area at Great Pond Bay is currently used as a dump site for trash and other refuse and debris (Figure 8.4). Evidence of soil staining from unknown discarded materials and/or liquids was also observed. Stormwater flows down the existing dirt road and paths, through the dump debris to the pond and beach area. The roadway and paths are highly eroded with deep ruts and gullies. The soil is also highly compacted from vehicular traffic and dumping activities. This area likely conveys large amounts of sediment and other pollutants to Great Pond Bay.

**Figure 8.4.** Dumping and debris at the Great Pond parking area

A series of minor site improvements at this property could alleviate dumping and reduce the threat of pollutant loading to the coastal waters. Installation of a guardrail or other suitable barrier at the entrance would restrict vehicle access and limit traffic to pedestrian use only. Sections of fencing or placement of large boulders at either end of the barrier may also be useful, to prevent visitors from bypassing the barrier in their vehicles. Limited vehicle access would, presumably, reduce the amount of dumping and introduction of potentially hazardous waste materials, and allow the area along the pond to naturally re-stabilize and re-vegetate. Large ruts and gullies may be backfilled with an appropriate soil or gravel to reduce further erosion. Restricted access should be accompanied with education and outreach including “no dumping” signage and trash cleanup events linked to the cleanup of Great Pond Bay.

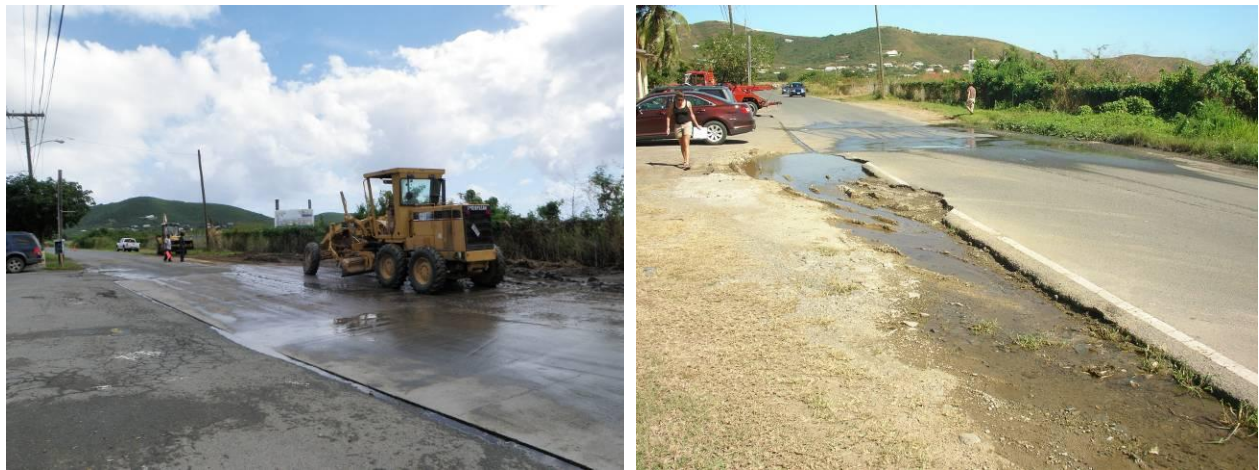
Several potential retrofit/drainage improvement sites were identified along Rt. 624 in the Great Pond Watershed. The most significant problem was identified near Milgie's Grocery (GP-RC-2) where drainage from the adjacent gut is not properly managed. Currently, water from the gut flows south until it reaches Rt. 624, where it then flows east along the road shoulder toward Milgie's before passing over the pavement and flowing to the south. Minor road flooding was witnessed during the site visit, but chronic flooding at the Milgie's Grocery property was reported (Figure 8.5). Erosion and undermining of the asphalt pavement at this location was also observed. Suggested drainage improvements include construction of a concrete drainage channel along the north side of Rt. 624 to direct runoff to the lowpoint in front of Milgie's. The existing drainage channel across Rt. 624, as well as the shoulder along the southern side, should be excavated and lowered to improve flow away from the roadway. Relocating the existing chainlink fence for the Wyndham property and selective vegetation management may also be necessary to address the drainage problem.

**Figure 8.5.** Road drainage issue in front of Milgie's Grocery.

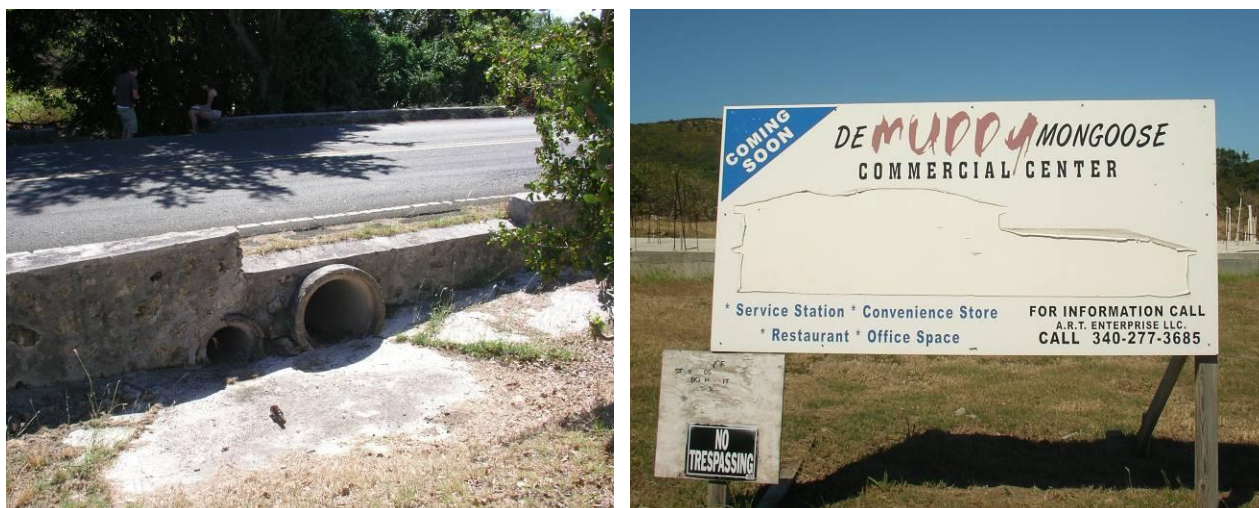
Two drainage improvement projects were identified at road culvert crossings along Rt. 624: GP-RC-1 and GP-RC-3. The GP-RC-1 culvert (located south of the proposed Muddy Mongoose commercial development) is an eroding culvert network in need of maintenance and stabilization (Figure 8.6). Currently road runoff bypasses an existing curb-cut in the downstream headwall and is causing erosion at the west end of the headwall. Additional curbing should be installed to convey runoff to the existing curb-cut. Riprap stabilization at the existing culvert splash pad is also recommended to impede further scour hole formation. General debris removal and vegetation management is suggested.

**Figure 8.6.** Culvert near Muddy Mongoose proposed development.

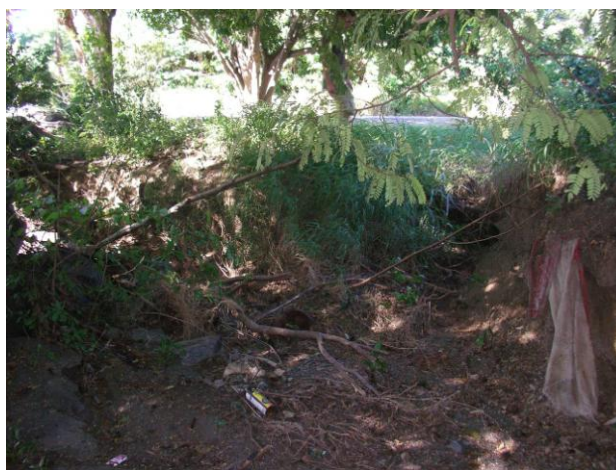
The West gut begins at Southside Road and passes through the Sally's Fancy neighborhood. A gut restoration/road improvement site was identified where the West gut begins at site GP-G-1. At this location, the gut receives runoff from Southside Rd. and the Marienhof neighborhood. The runoff is not properly collected in drainage infrastructure; instead it flows off of the shoulder and into the gut. Significant gut erosion has occurred and the roadway has been undermined as a result of improper stabilization. Boulders had previously been placed at this location to impede the erosion but the attempt failed. Several nearby, large trees have been uprooted. The bank erosion in the gut is so great that considerable property loss has occurred at the neighboring properties. Curbing should be added along the roadway at this location and a paved flume installed to collect the runoff. A riprap splash pad should be placed in the gut to minimize the erosive forces of the runoff. Bank stabilization measures in the gut are also recommended to prevent further property loss (Figure 8.7).

**Figure 8.7.** West gut erosion and trash.

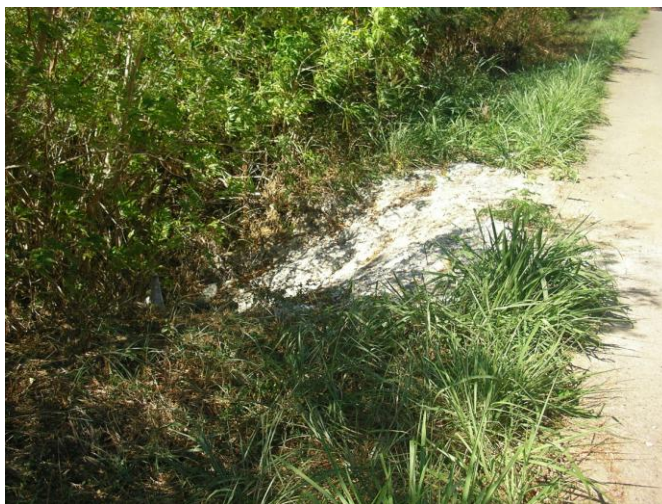
A 24-inch CMP culvert was identified on East Maria Lane at the GP-RC-4 site. The culvert inlet is partially clogged which has contributed to runoff bypassing the culvert and flowing off the roadway to the south. Significant erosion has resulted due to the steep terrain and improper stabilization. Concrete had been placed in an attempt to manage the road runoff but it is bypassed on both sides (Figure 8.8). The culvert is currently 'hanging' about three feet above ground. An improved paved drainage flume and curbing should be installed to adequately collect the road runoff and convey it to the outfall. Riprap should be placed at the outfall to arrest the existing bank erosion and scour hole formation. The culvert should be shortened to conform to the existing topography. Debris removal at the culvert inlet is recommended.

**Figure 8.8.** Attempt at concrete flume to manage runoff on East Maria Lane above culvert (GP-RC-4).

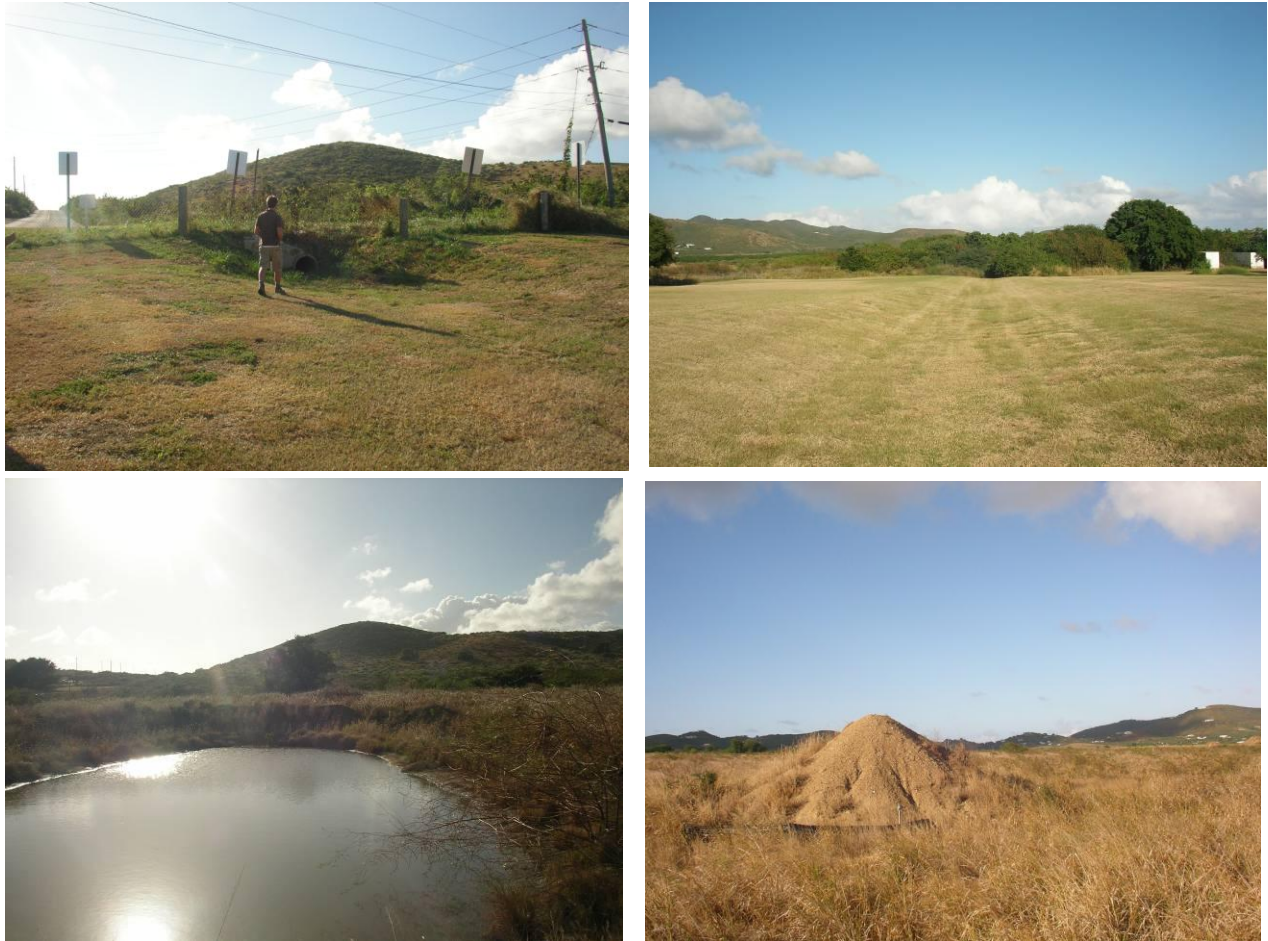
The Boy Scout camp contains a drainage outfall-grassed swale system, a gut that runs through the property, a mangrove forest, and recent excavation of drainage channels and detention ponds (Figure 8.9). All developed areas throughout the Boy Scout property were found to be in good condition. The outfall-swale system that drains to the property from Southside Rd had no signs of erosion and ample grass coverage. The gut downstream of the swale was also very stable. Bank stabilization was adequate due to the thick mangrove-manchineel forest downstream and the tall guinea grass upstream.

West of Great Pond there was recent excavation of earthen drainage channels and detention ponds for controlling water and runoff from the proposed Wyndham Resort development (see Figure 8.8). The drainage channels are simply trenches that were dug to redirect water to the constructed ponds. Excess soil from the excavation remained on-site, adjacent to the basins. Since that time, guinea grass was able to establish on the bare soil which appears to have kept erosion and sedimentation down. If the resort project does not take shape in the near future, consideration should be given to filling in the trenches and basins to restore more natural drainage patterns.

**Figure 8.9.** Clockwise from top left: Culvert leading from Southside Rd. to grass swale at Boy Scouts site; Grass swale leading from culvert outfall to Great Pond on Boy Scouts property; Detention pond adjacent to Great Pond near Boy Scouts property; Soil mounds from Wyndham excavation.

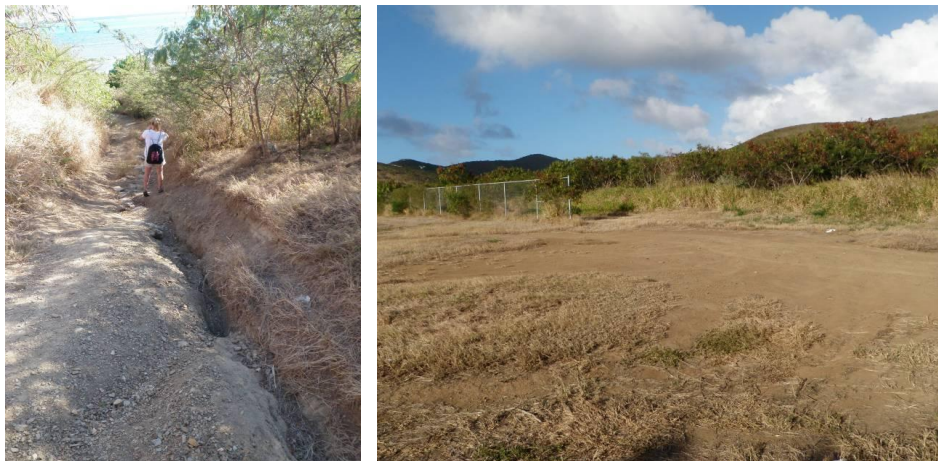
The adjacent open area north of the EEMP is currently being considered for a large campground. In the northeastern corner is an active parking area that connects to an eroded trailhead leading down to the beach. EEMP staff indicated that observable erosion occurs during rain events and that trail stabilization and parking management at this location would help reduce sedimentation. The trail is approximately 150 feet long at a 2:1 to 3:1 slope. Deep gulying has occurred in the trail (Figure 8.11). Basic trail stabilization techniques including waterbars and steps, as well as management of flow from the parking area could help stabilize the trail. Ownership of the trail is uncertain.

**Figure 8.11.** Eroded trail to beach (left) and parking area (right)

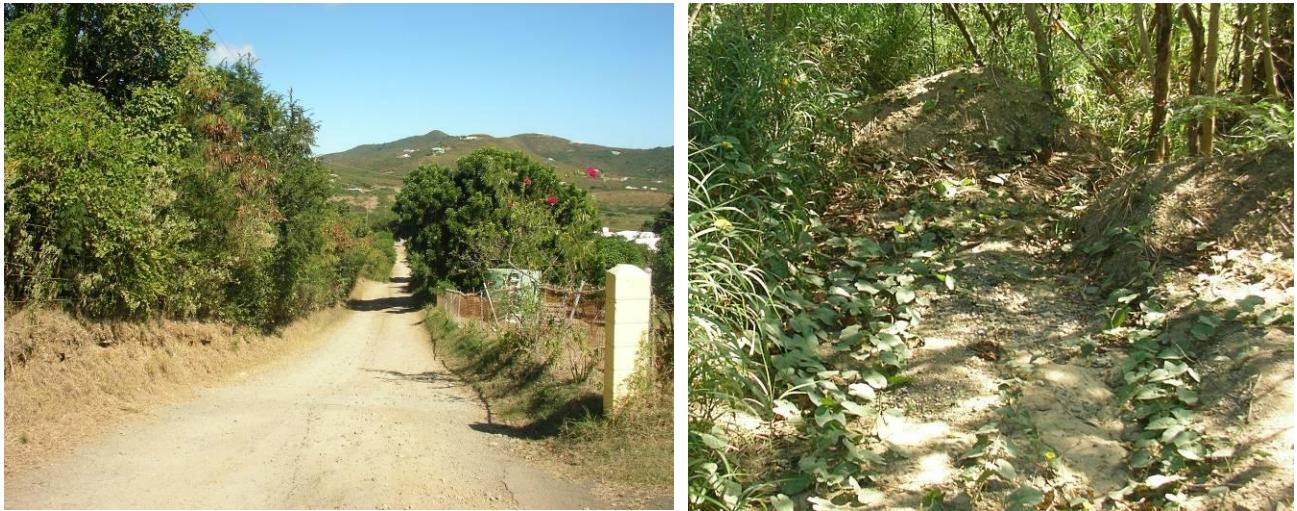
The Sally's Fancy neighborhood is located northeast of the Southside Rd./Rt. 624 intersection. The neighborhood includes a mix of topography, landuse, and parcel size and has two guts flowing through it (Figure 8.12). The topography varies from moderate in the north and very flat topography in the south. The parcels, which are primarily developed, range from quarter-acre to three-acre lots. The larger parcels are primarily brush or tall grass that may include some agricultural activities. At least two lots were identified as possible automobile junk yards. Other than the two highways that border the neighborhood, the roads are mostly dirt or gravel. Severe rutting was observed in the low-lying areas. Some of the ruts were in the process of repair with crushed stone. A high density of dogs was observed in this neighborhood.

An area of future concern near Sally's Fancy is the proposed Wyndham Golf Resort & Casino, which is directly across from Milgie's Grocery. The local gut flows directly into this property and the topography is extremely flat. Any impoundment to the gut will likely contribute to more severe flooding problems in Sally's Fancy neighborhood. Any future downstream development should evaluate these potential impacts during the planning phase.

**Figure 8.12.** Sally's Fancy neighborhood (left); sediment dumping in gut (right).

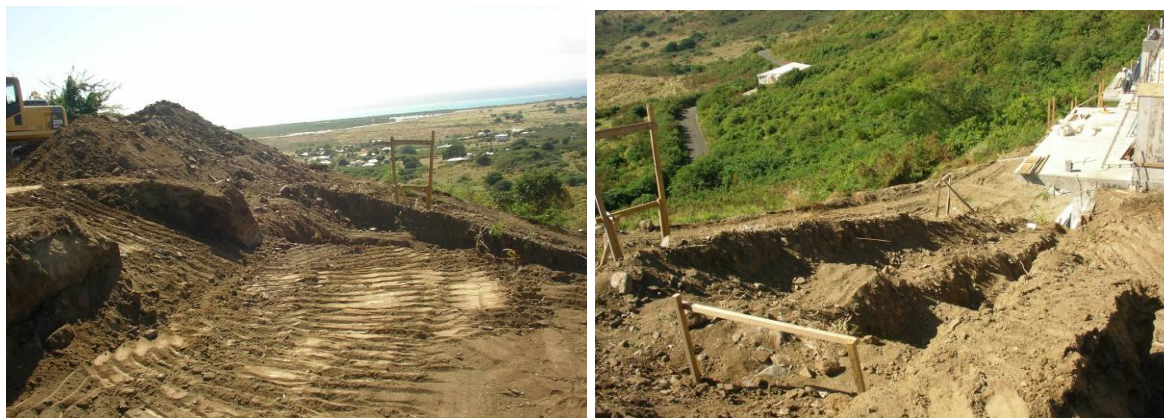
The Marienhof neighborhood is located in the northwest corner of the watershed and is accessed by Southside Rd. It is primarily located in the hills and consists of large parcels on steep terrain. Few of the parcels are developed, with the majority remaining forested. There is some new construction currently taking place. At one recently cleared lot (Figure 8.13), no erosion/sediment control practices were installed and much soil was exposed, creating high potential for down-gradient sedimentation. Most of the roadways are paved but with minimal drainage infrastructure. A culvert was found with significant erosion at the outfall. An ineffective attempt was made to manage the runoff at the outfall by pouring a concrete

drainage flume/splash-pad. This measure failed due to water bypassing and scouring beneath the flume. Some dirt driveway erosion was identified that was contributing sediment onto the roadways.

**Figure 8.13.** Slope clearing at residential construction site in Marienhoj.
